OPERATION PLUMBBOB

NEVADA TEST SITE
MAY-OCTOBER 1957

Project 30.7

TEST OF GERMAN UNDERGROUND
PERSONNEL SHELTERS

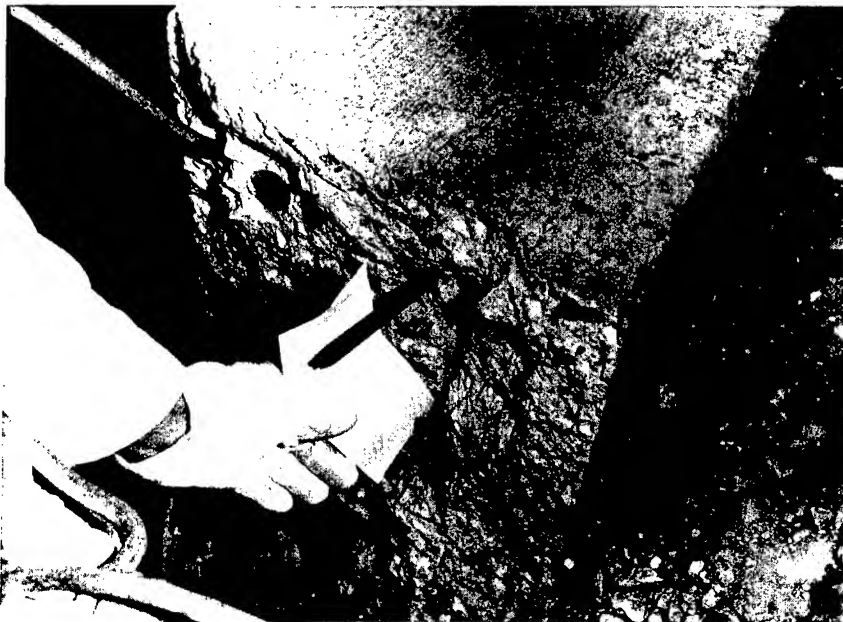
(a) *Entranceways.* In the ramp entrance facing GZ separations formed at the intersections of the interior and exterior walls with the ramp slab. The interior wall was pulled away from the slab 7 in. at the bottom and $\frac{1}{16}$ in. at the top of the ramp. The intersection of the ramp and exterior wall was similar to that at the interior wall; that is, the crack varied from 4 to 7 in. near the bottom to zero inches at the top of the ramp. Bowing of the interior wall into the backfill was produced at the quarter-height along the contraction joint. A $\frac{1}{16}$ - to $\frac{1}{2}$ -in. vertical crack was formed near the bottom of the ramp. This crack terminated at a laminated area located at the mid-height of the wall. There was spalling on both sides at the upper section of the crack. Cracks varying from $\frac{1}{16}$ to $\frac{3}{8}$ in. in width, perpendicular to the plane of the ramp, were located approximately 2 ft on center along the length of the wall. The majority of these cracks ran the full height of the wall. A crack starting at a chipped-out section located at the intersection of the end of the roof slab and the interior wall ran diagonally toward the top of the wall. The section of the wall above this crack was deflected back into the fill. The exterior wall damage was similar to that described for the interior wall. A chipped section of the exterior ramp wall was located approximately 4 ft above the landing at the contraction joint. A horizontal crack, with spalling on both sides, above this section produced a $\frac{1}{2}$ -in. bow in this wall. There were numerous diagonal cracks perpendicular to the plane of the ramp located approximately 2 to 3 ft on center in the upper two-thirds of wall. These cracks varied in size from $\frac{1}{32}$ to 1 in. in width. The top of the parapet located above the landing roof slab that faces GZ was deflected into the backfill 6 in. at the intersection of the exterior wall and 1 ft at the interior wall. The corners of the parapet and side walls were chipped, and the reinforcement was exposed.

Fig. 3.21—Detail of necked-down reinforcement torn from interior wall at parapet (structure RAa).

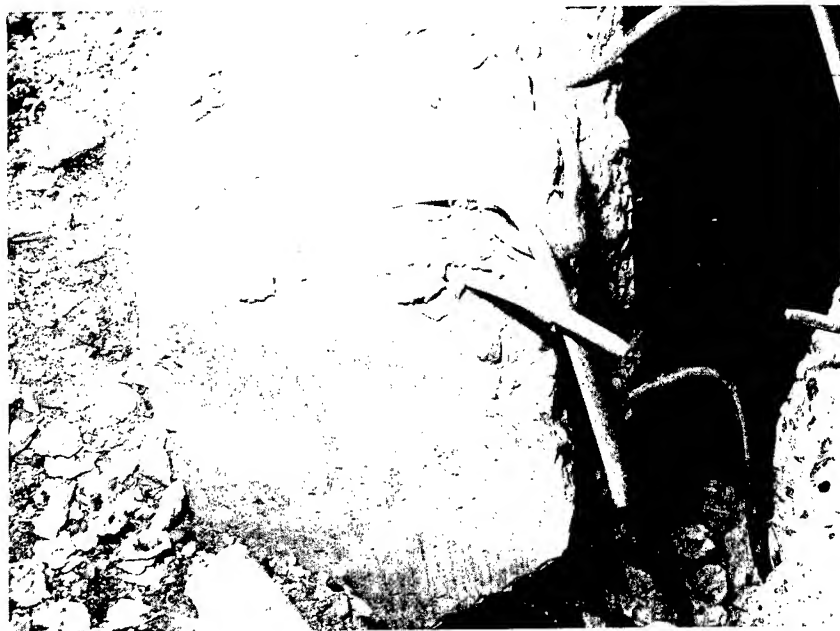
Fig. 3.22—Detail of exposed reinforcement after chipping at corner of interior wall and parapet facing toward GZ (structure RAa).

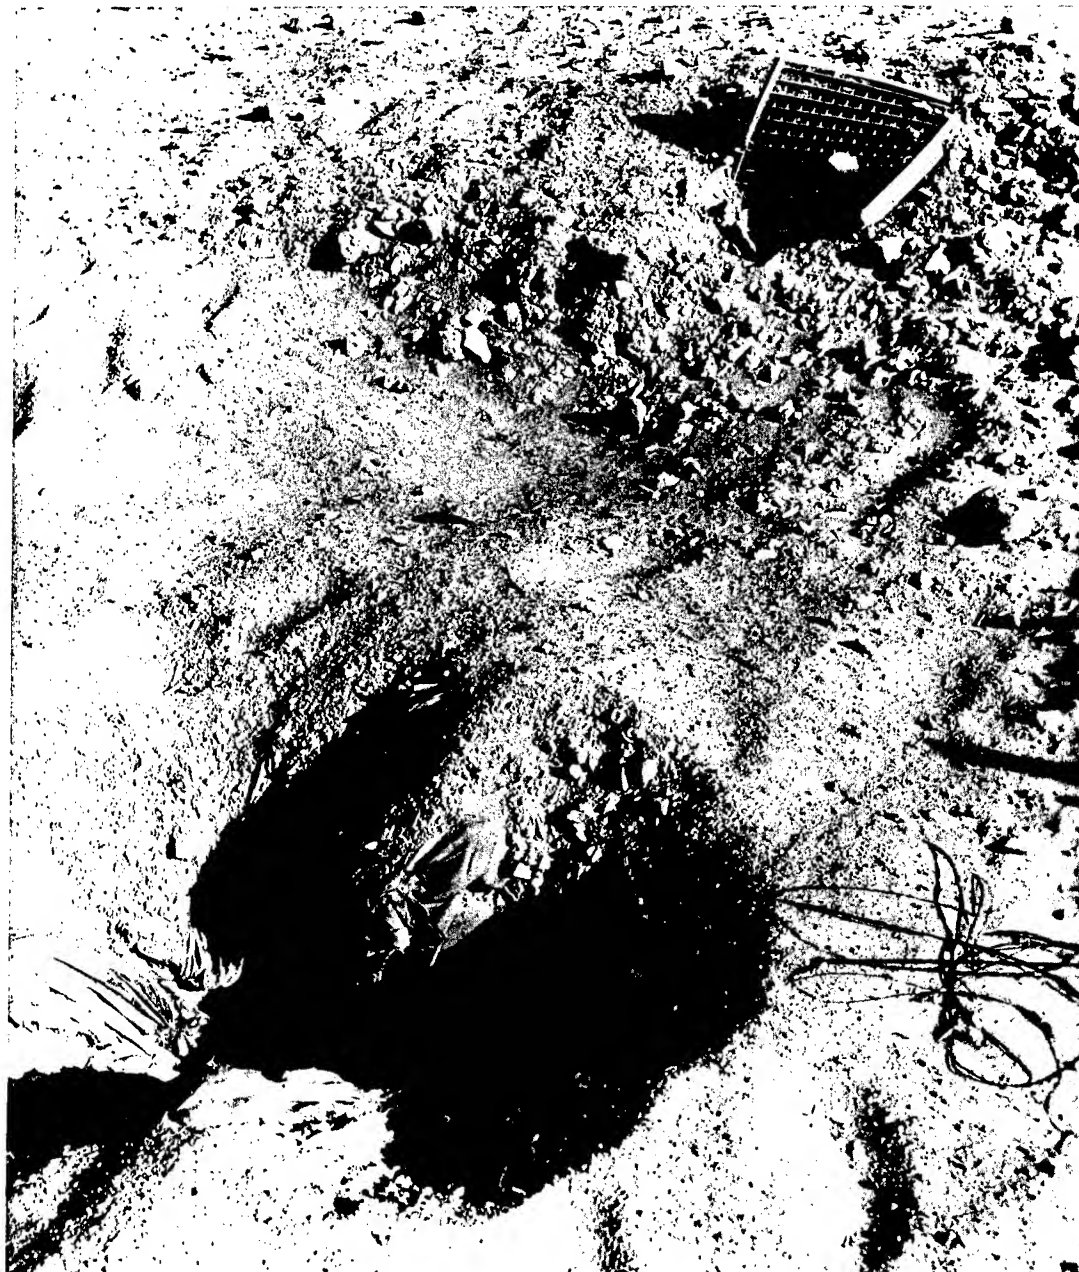
The emergency-exit hatch cover was blown down into the exit tunnel and deposited opposite the small blast door. The exit hatch cover showed no other damage except straightening of the hinge support straps. The releasing mechanism was also undamaged.

Fig. 3.24—Emergency-exit shaft (structure RAa).

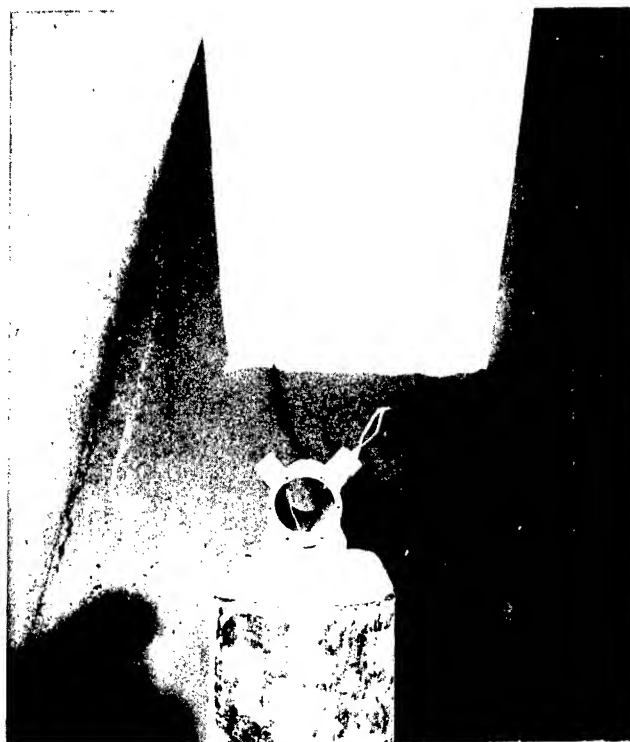
Fig. 3.49—Looking up entrance toward GZ, after cleaning (structure RAc).

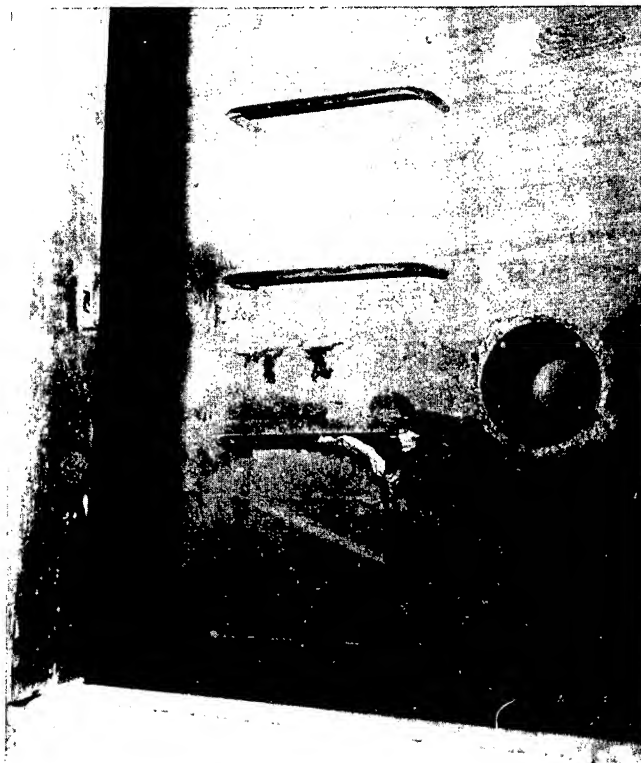
Fig. 3.67—Emergency-exit shaft from chamber between small blast and gastight doors (structure CAa).
